CASE HISTORY

Produced Water Handling

Gulf of Mexico Major Oil Company Process Repair & Bypass

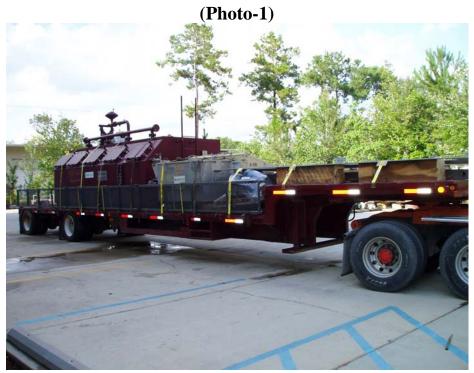
This photo shows Enviro-Tech Systems crew mobilizing

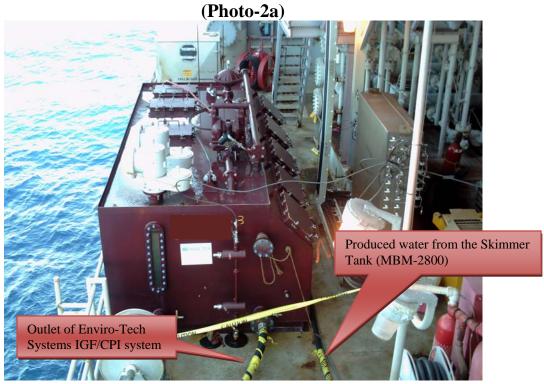
(Photo-2b)

Enviro-Tech Systems by-pass CPI/IGF combination Unit

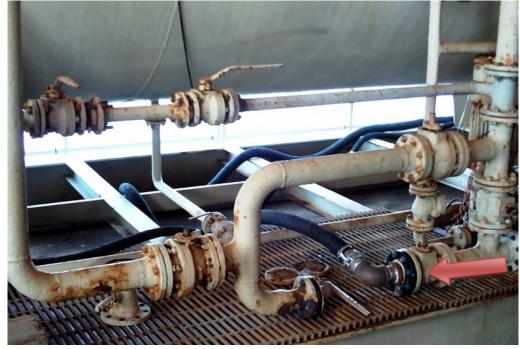
(Photo-3)

Shows how the Enviro-Tech Systems Team tied into the outlet of the Skimmer tank

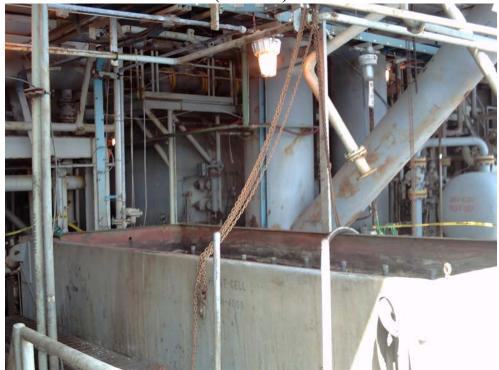
(Photo-4)

Starting to disassemble the existing IGF

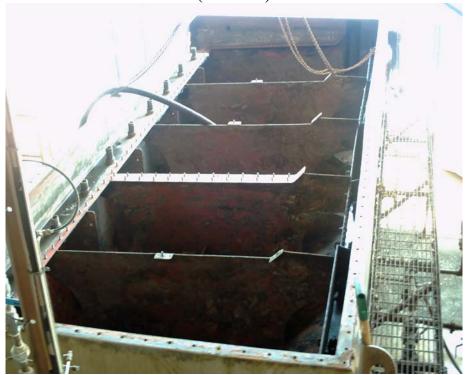
(Photo-5)

The photo shows the top cover plate removed and the IGF Cleaned by Enviro-Tech

Systems Personnel

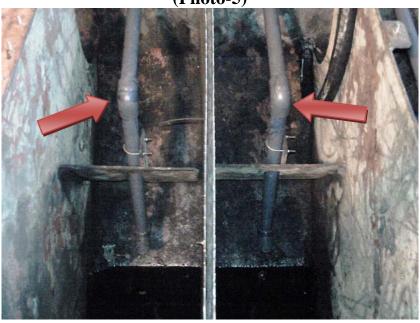
This photo shows the installation of the new Eductor system

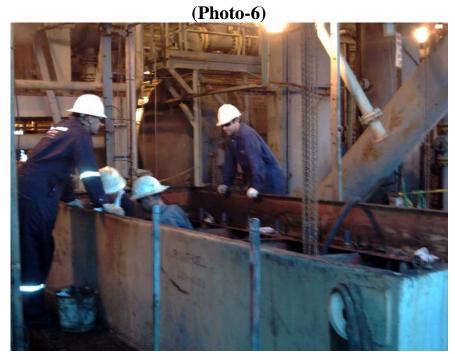
The photograph shows the Enviro-Tech team working to install new internal parts.

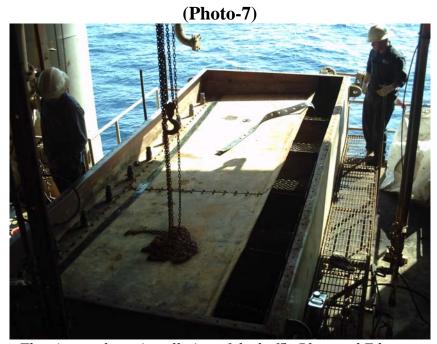
The picture shows installation of the baffle Plate and Eductors
