## CASE HISTORY

*Produced Water Handling*

**Gulf of Mexico Major Oil Company**  
**Process Repair & Bypass**

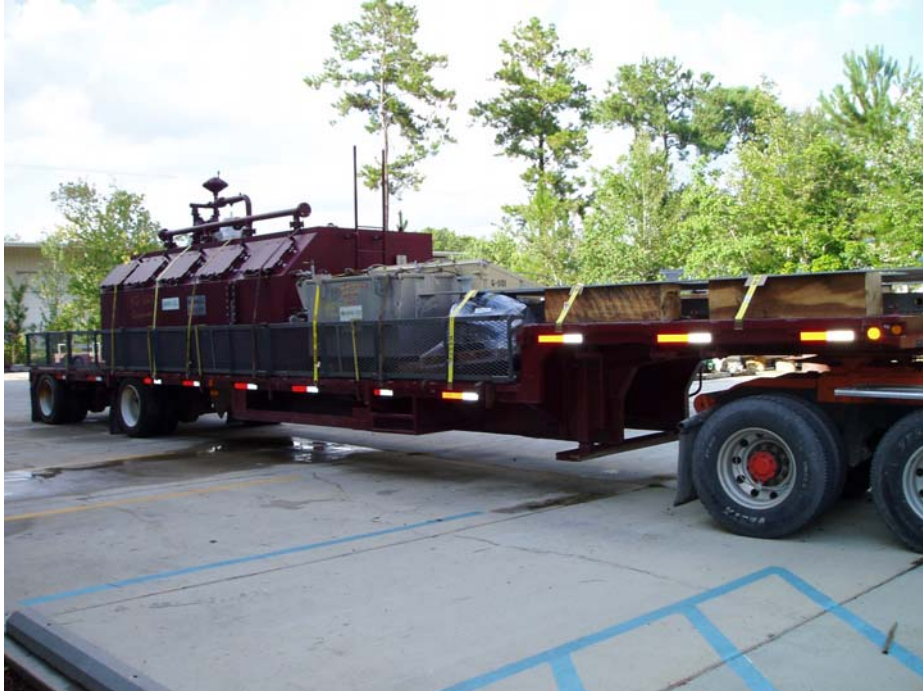
**(Photo-1)**

*This photo shows Enviro-Tech Systems crew mobilizing*

- a. Remove Eductors and internal piping
  - b. Remove Anodes
- B. Enviro-Tech Systems crew mobilizes two (2) days in advance of the start of project. (photo-1)

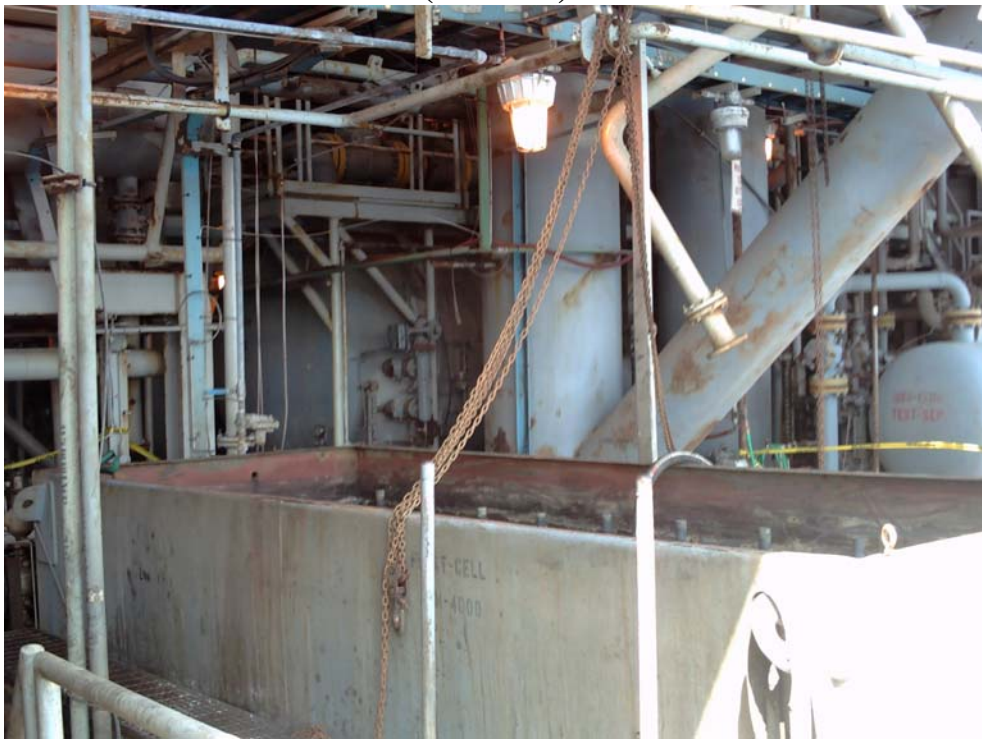
**(Photo-3)**

*Starting to disassemble the existing IGF*

- E. Day 3,4,5,6, start disassembly of the existing IGF and the vessel cleaning and installation of the new internal parts (multiple photo's 3,4,5,6,7)

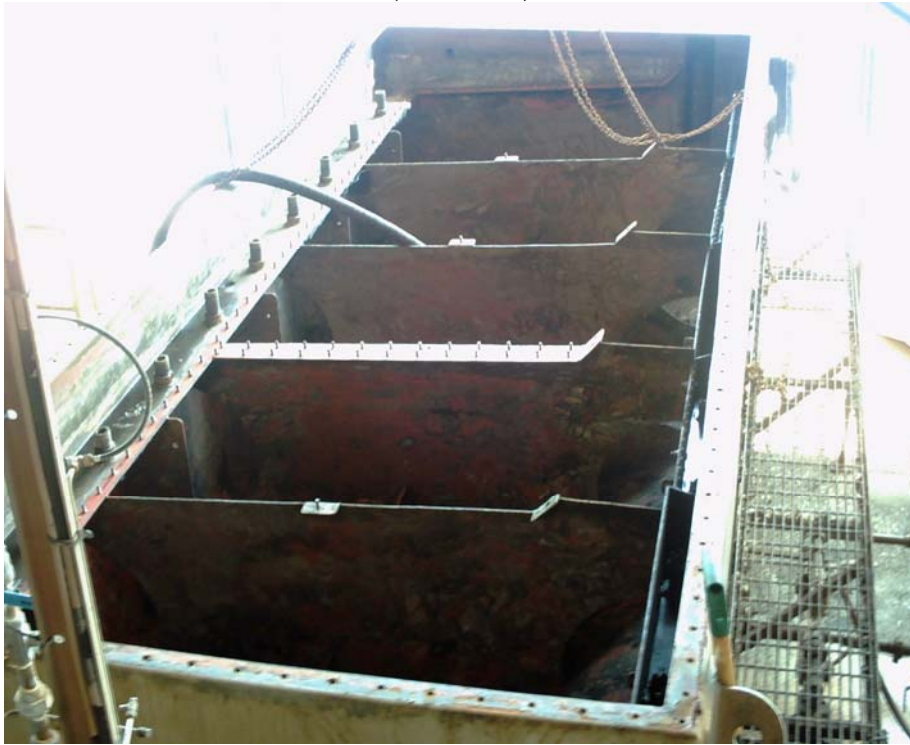
**(Photo-4)**

*The photo shows the top cover plate removed and the IGF Cleaned by Enviro-Tech  
Systems Personnel*

- H. Work Parameters consisting of the following:
- a. Disassemble tank removing top and internal covers
  - b. Remove oil weir
  - c. Clean debris and sludge from tank

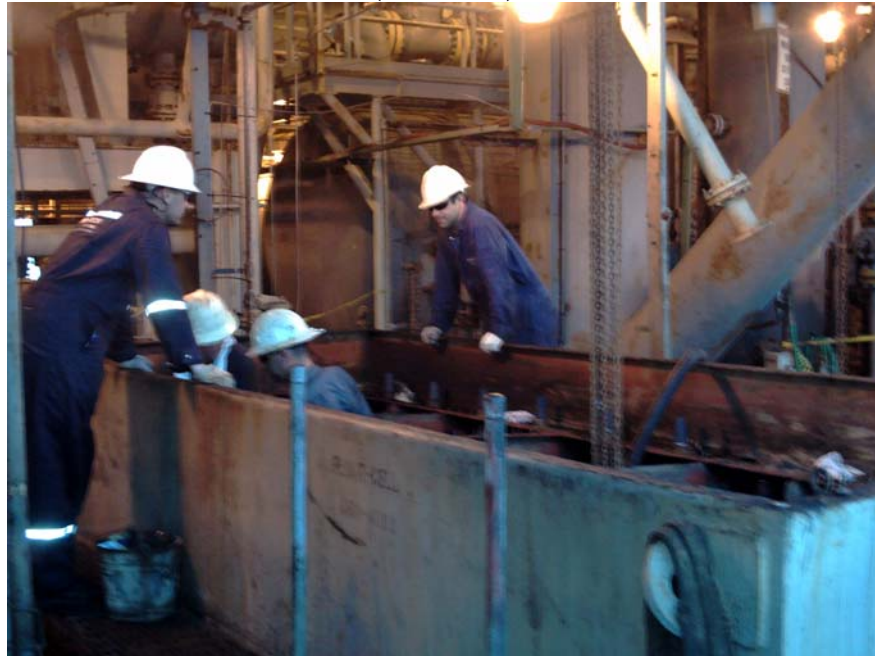
**(Photo-6)**

*The photograph shows the Enviro-Tech team working to install new internal parts.*

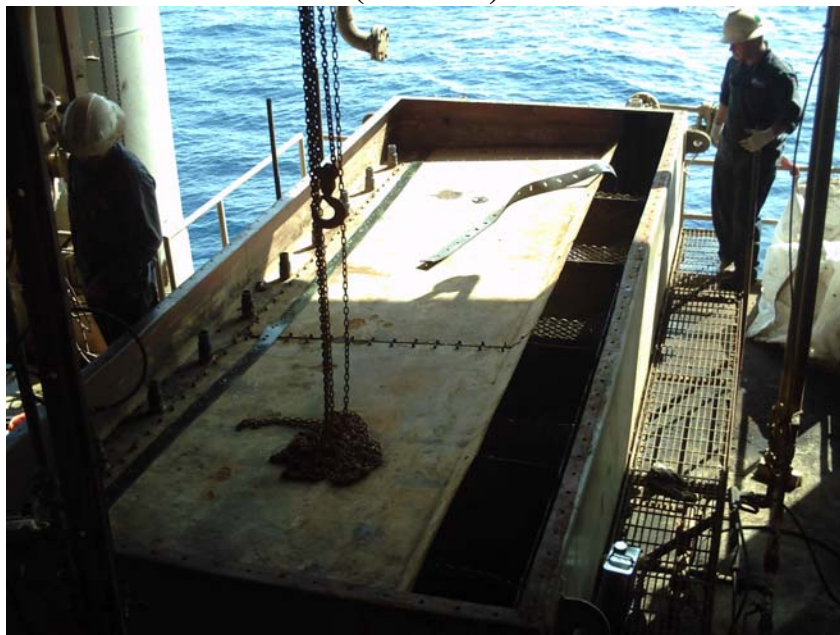
**(Photo-7)**

*The picture shows installation of the baffle Plate and Eductors*
